FINAL REMEDIAL INVESTIGATION REPORT VOLUMES 1 OF 2 AND 2 OF 2 FOR
INCINERATOR DISPOSAL SITE AND FORMER SKEET RANGE NAS CORPUS CHRISTI TX
7/1/2013
TETRA TECH

Remedial Investigation Report Volume 1 of 2 Incinerator Disposal Site and Former Skeet Range

**Naval Auxiliary Landing Field Cabaniss
Corpus Christi, Texas**

**FINAL
REMEDIAL INVESTIGATION REPORT
FOR
INCINERATOR DISPOSAL SITE AND FORMER SKEET RANGE**

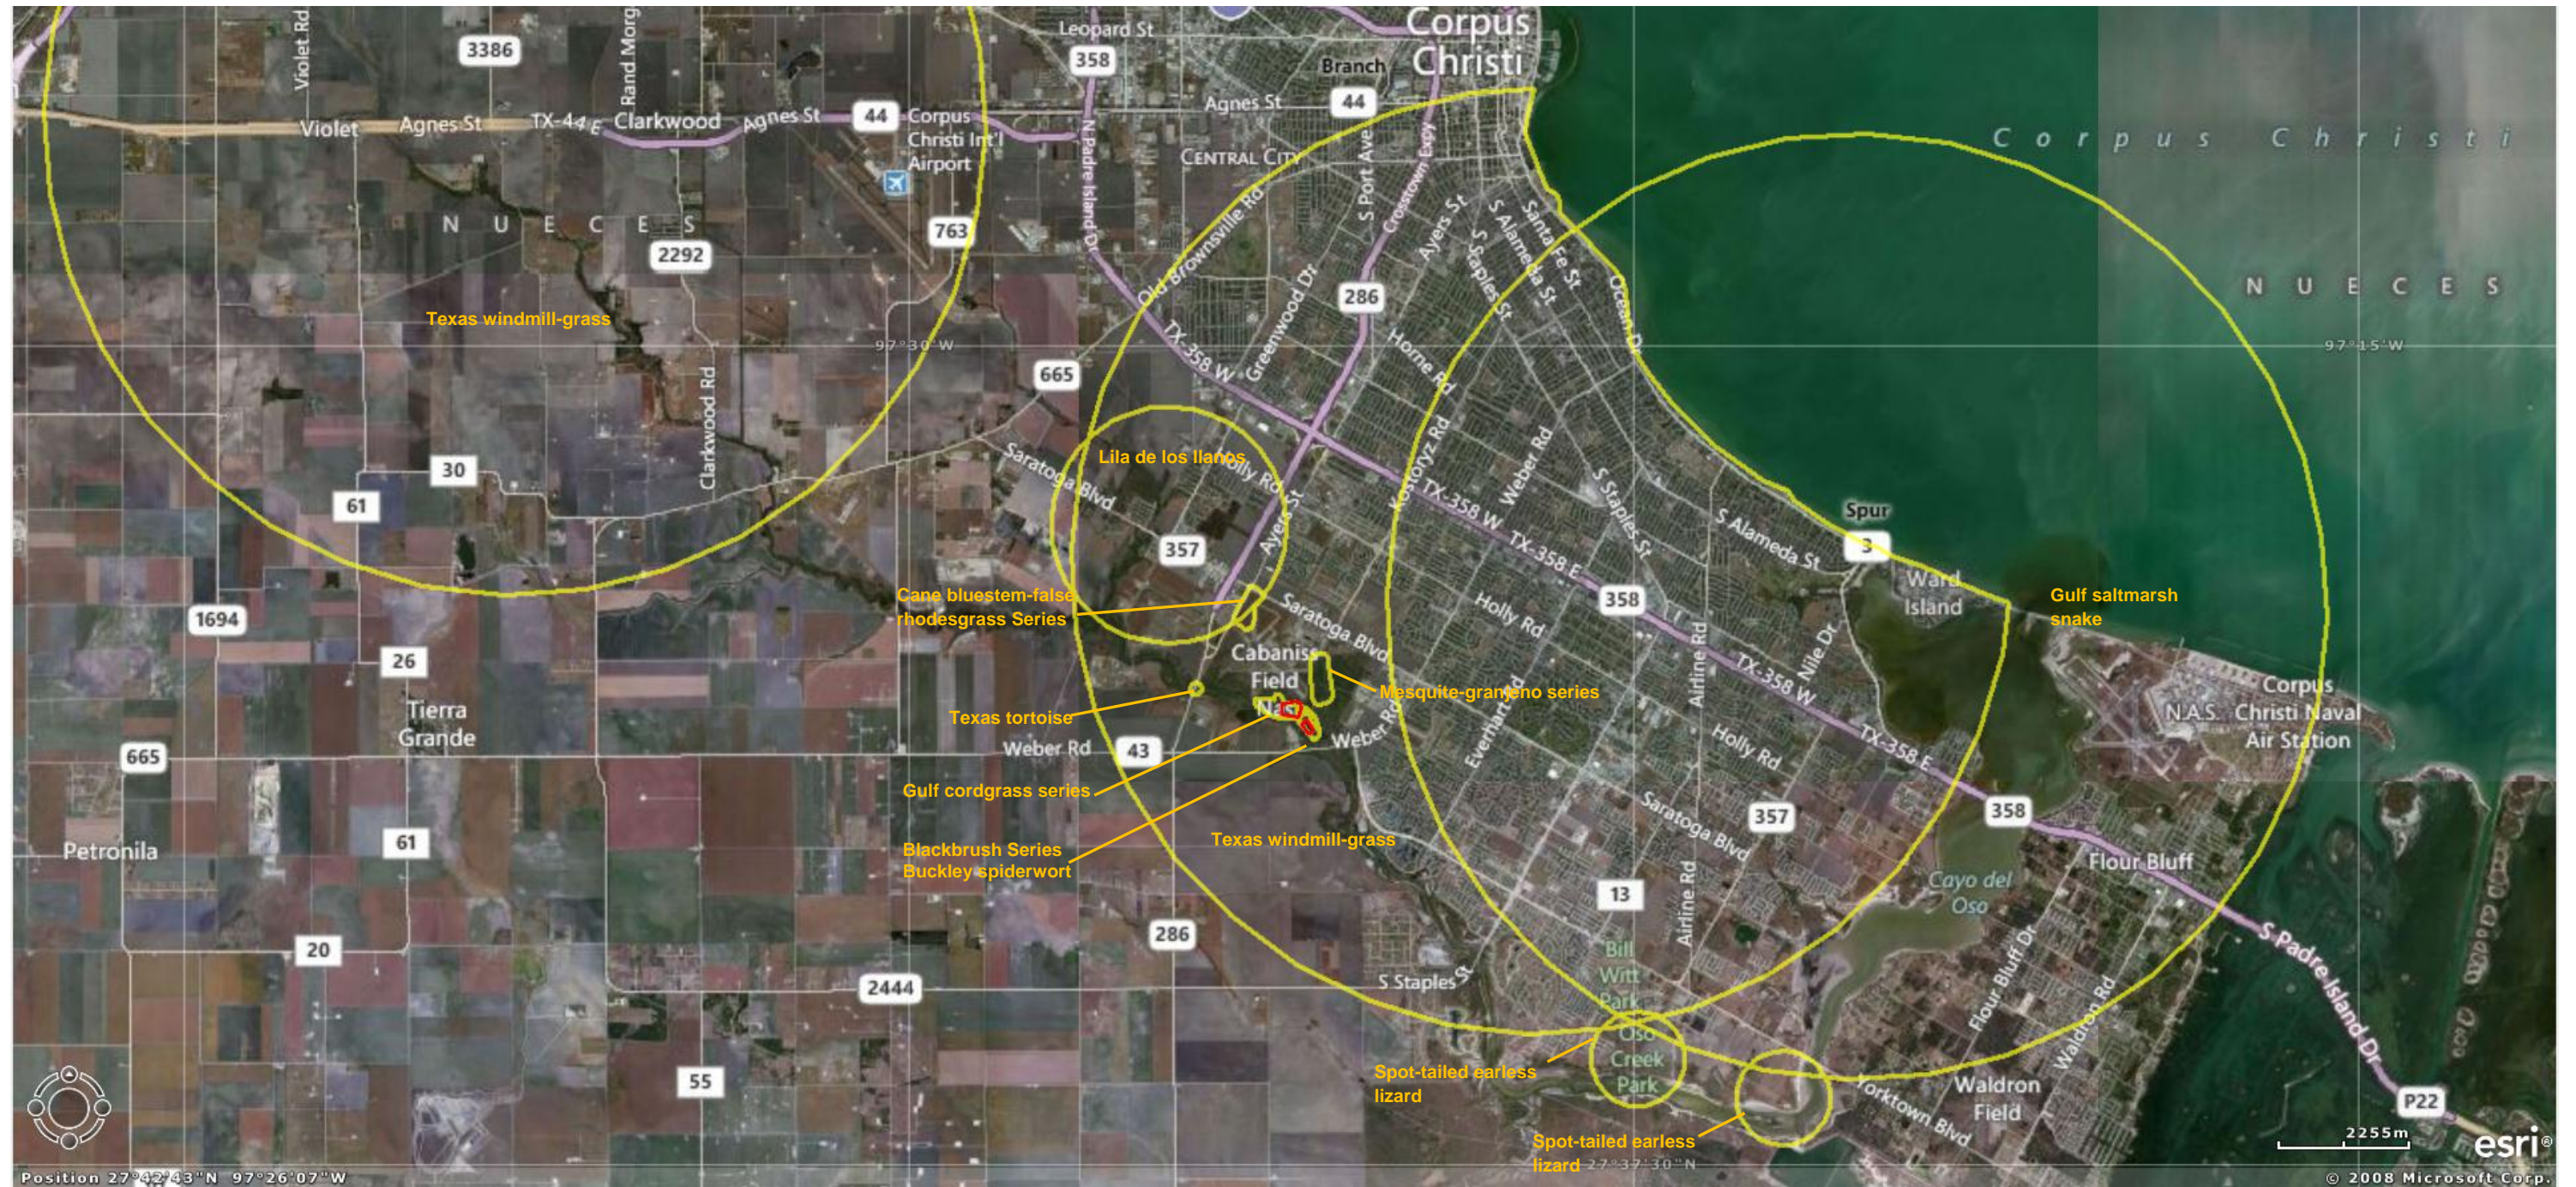
**Locations of Observations of Threatened, Endangered, and Rare Species
In Oso Creek Northwest USGS Quadrangle
As Provided by the Texas Natural Diversity Database**

Yellow polygon: Combination of the geographic location of the reported observation and the locational uncertainty of the observation
Red polygon: Location of Incinerator Disposal Site and Skeet Range.

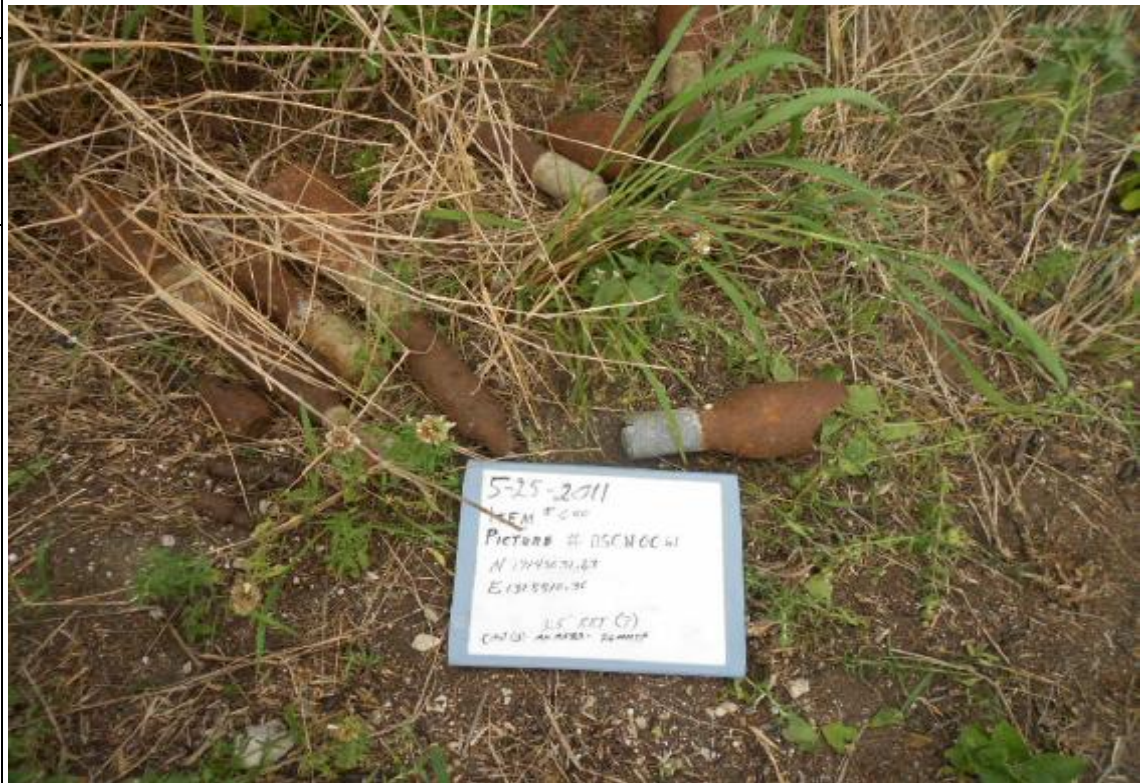
PHOTO 56 (DSCN0062)

MEC

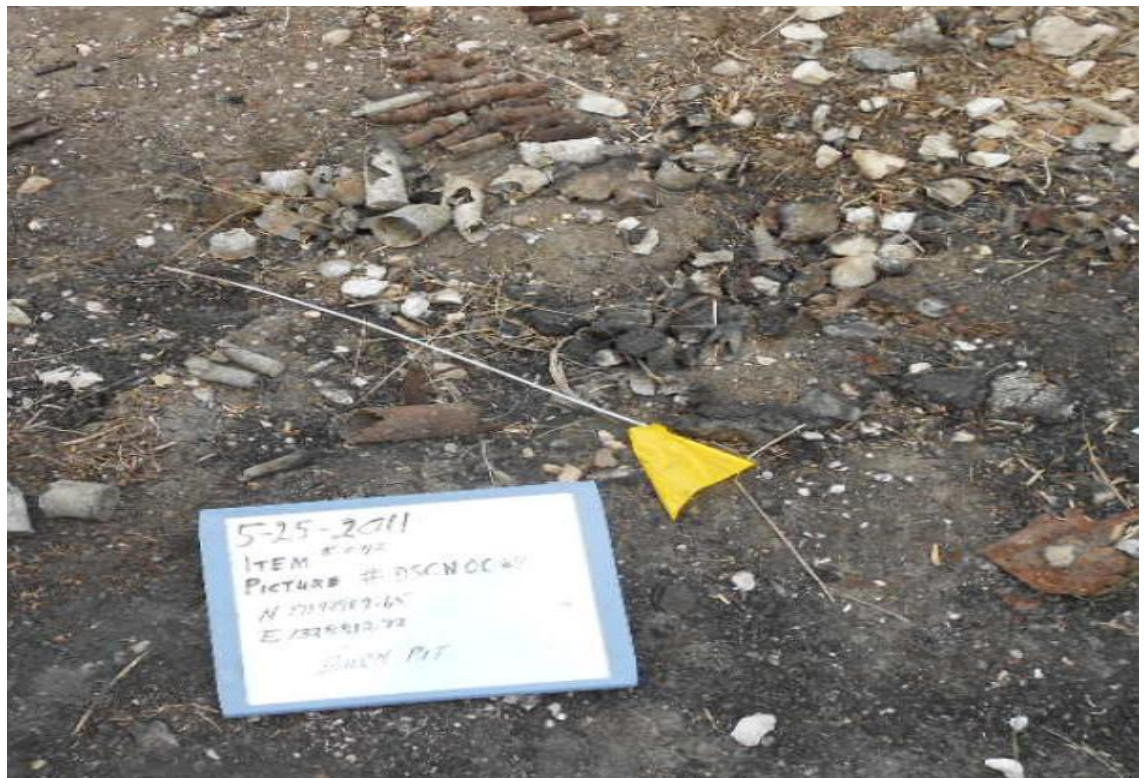
Burn Pit
